# UL Verification Test Report

Type: INVERTER (1KVA 48V SOLAR INVERTER)

Scope of Work: 1) Test protocol - TESTING of INVERTER which has reference to test standard **IEC-61683**  
2) Test protocol – ENVIRONMENTAL TESTING of INVERTER which has reference to test standard **IEC-60068-2-(1, 2, 14, 30)**

Model Number: 1KVA / 48 VDC PCU

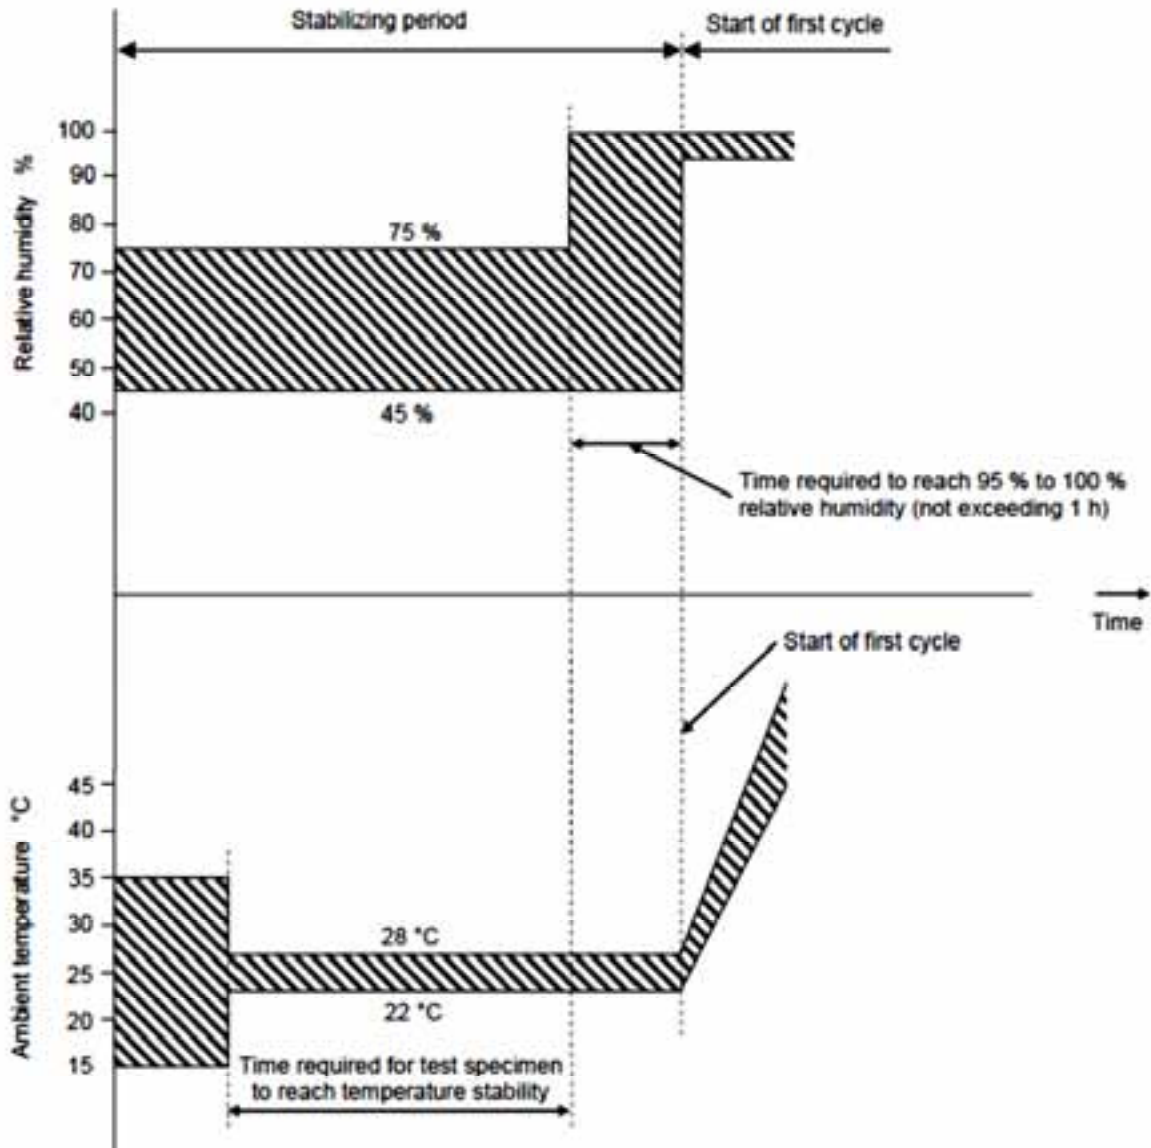
Figure 1 – Test Db – Stabilizing period

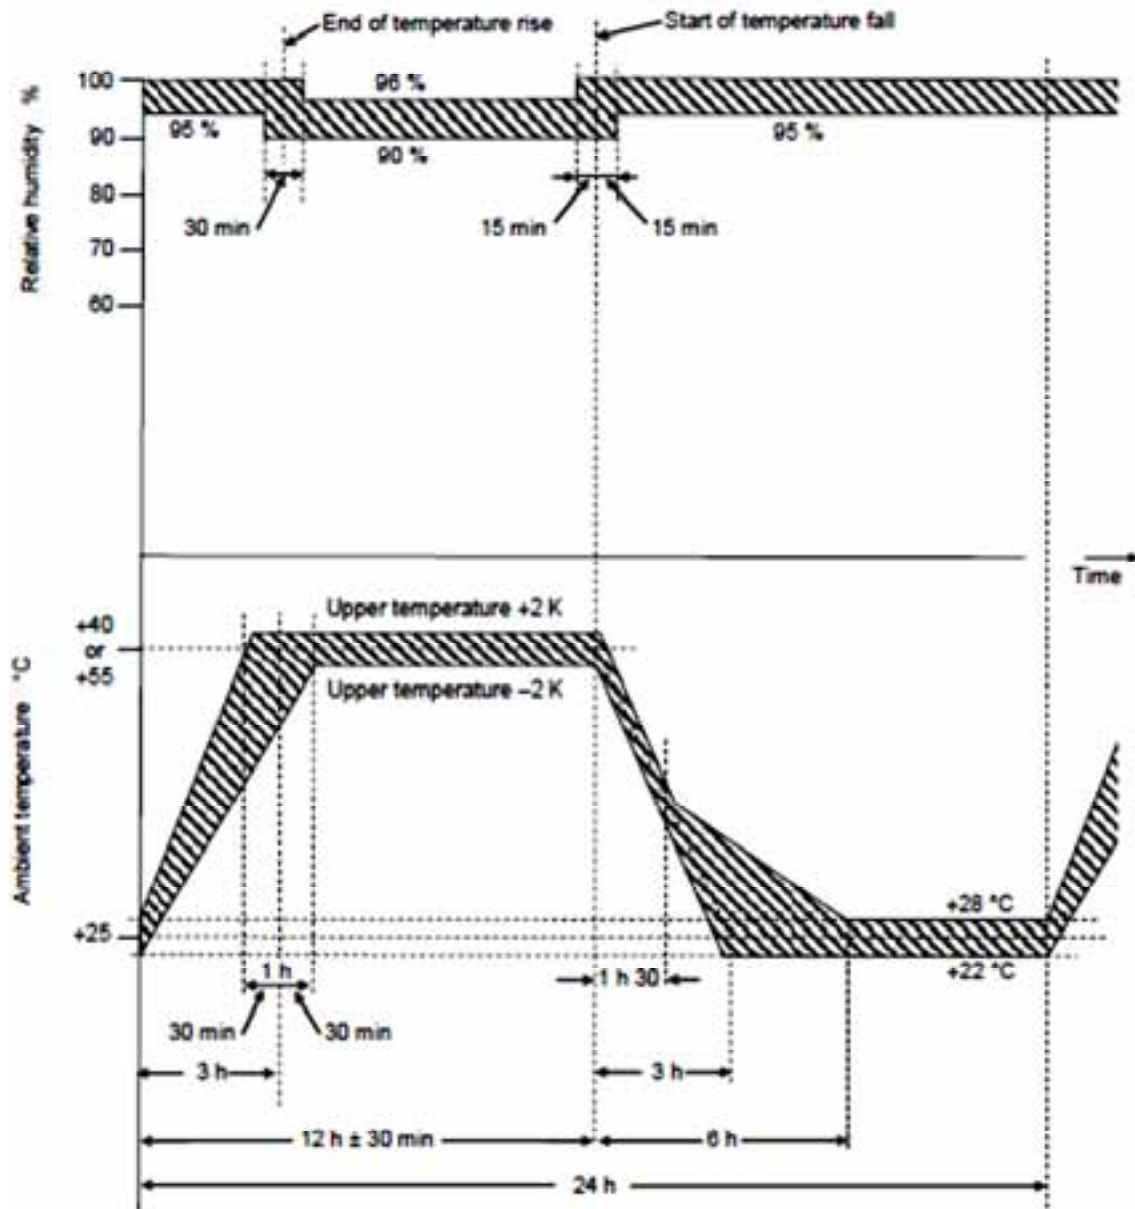
Figure 2 – Test Db – Test Cycle – Variant 1

1.4.b.	TABLE: Damp Heat Test	RESULT
Test Date (MM/DD/YYYY) start/end .....	03/05/2013	
Type of test	[ X ] Db	
Test condition Temperature	25°C to 55°C±2°C,variant 1 ,12+12Hrs cycle	
Test condition Humidity	93 ± 3% RH	
No. of Cycles..... :	2	
Sample #	Visible Defect	—
1578131	No visual defects observed	Satisfactory
Supplementary information:	NA

**Variant 1**, where the rate of temperature fall shall be closely controlled during the first 90 minutes and the relative humidity shall be not less than 95 % except for the first 15 min when it shall be not less than 90 %. This variant requires specially designed chambers.

**Variant 1** is particularly suitable for specimens where moisture may penetrate due to the breathing effect for example, specimens which include hollow spaces where condensation may occur on internal surfaces.

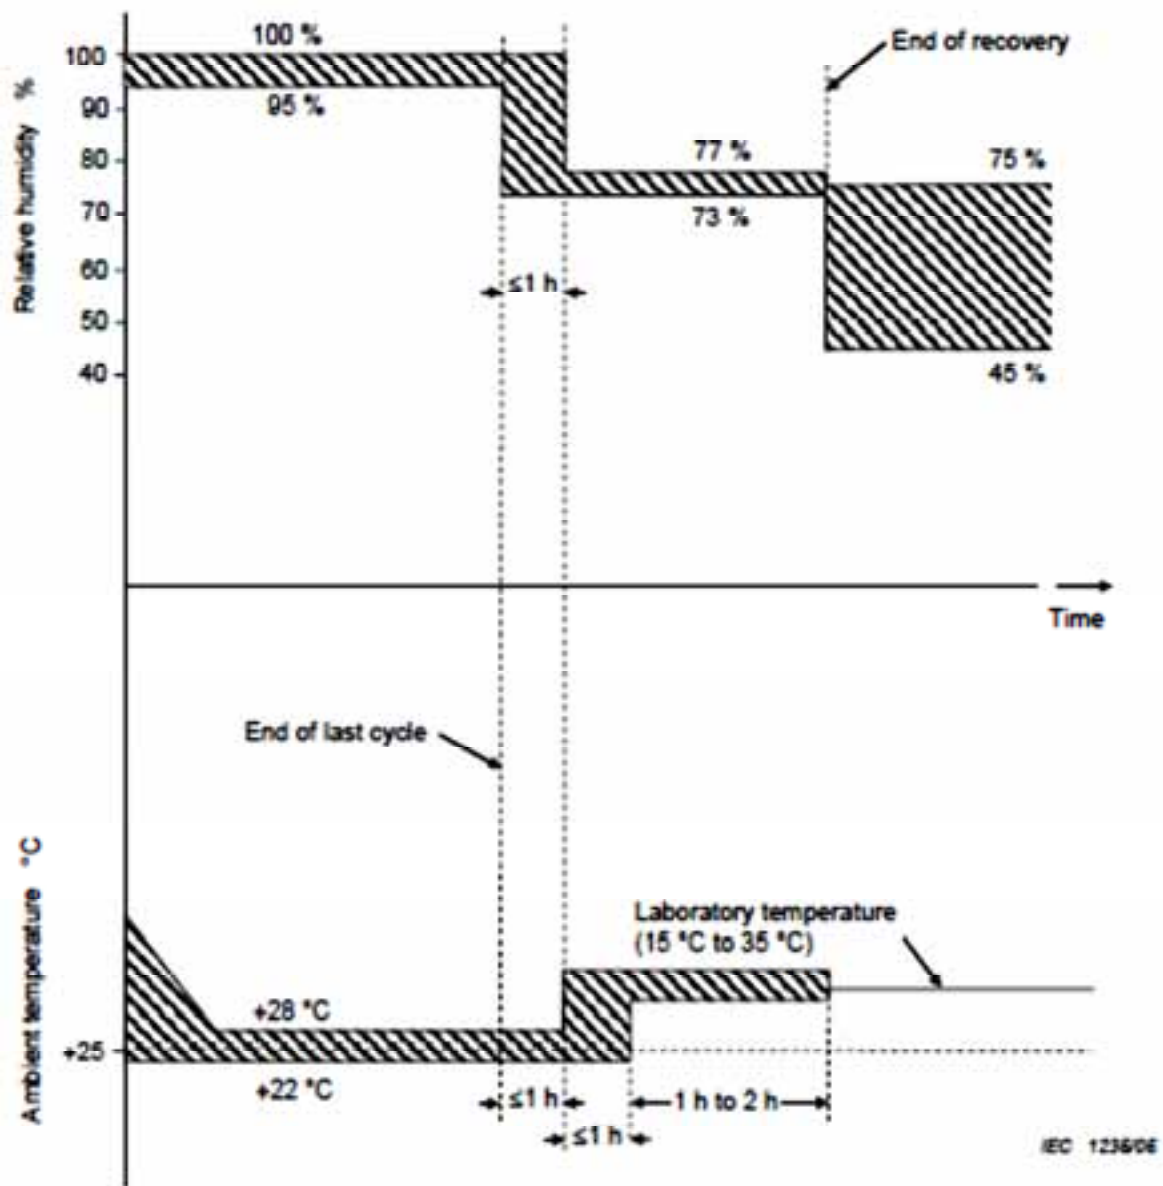
Figure 3 – Test Db – Recovery at controlled conditions
